Embrittlement of a Platinum-Iridium Screen

10 January 1999

G. L. STECKEL and N. MARQUEZ
Mechanics and Materials Technology Center
Technology Operations

**THE AEROSPACE
CORPORATION**
El Segundo, California

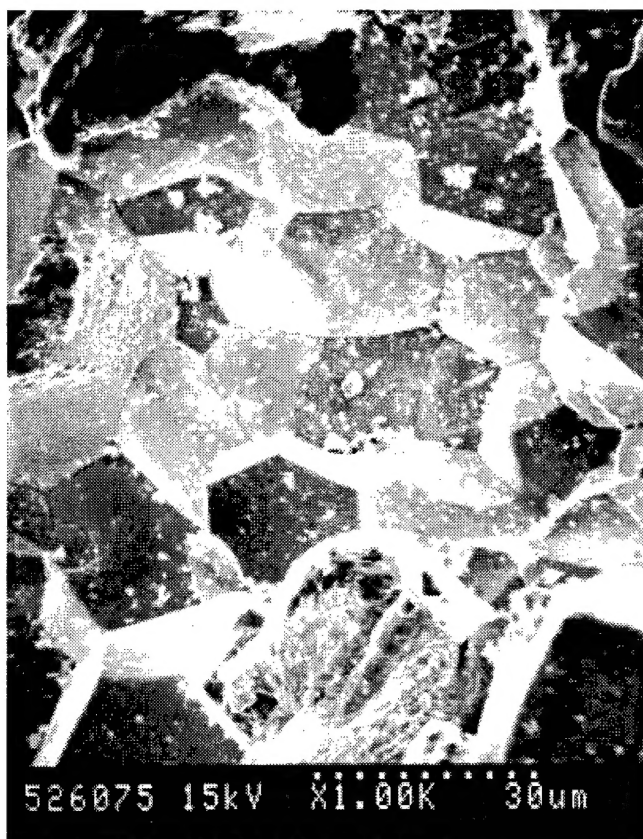
There was approximately a two-month delay between discovery of the wire fragments and the eventual disassembly of the motor discussed above. Thus, a preliminary failure analysis was performed on the wire fragments retrieved from the nozzle bag. Initially, scanning electron microscopy (SEM) utilizing energy dispersive X-rays (EDX) for chemical analyses was performed. SEM revealed the brittle intergranular nature of the fracture surfaces as shown in Figure 3. It is also apparent from

Figure 3 that the grain size of the Pt-Ir wire was unusually large. The ASTM grain size was approximately No. 7, which corresponds to an average grain diameter of 32 μm . It was also determined that the fractures consistently occurred at mesh bend points on the wires as shown in Figure 4. EDX indicated that the wire composition was approximately 88wt% Pt and 12wt% Ir. The only other element detected on the wire fractures or outer wire surfaces was aluminum. The presence of Al was attributed to catalyst particles that consist of Ir on an Al_2O_3 carrier. Catalyst particles can be seen on the fracture surface in Figure 3. No potentially embrittling contaminants were identified on the wire fracture surfaces.

Figure 3. SEM micrograph of fracture surface of Pt-Ir wire fragment. Particles on surface are from the Ir/ Al_2O_3 catalyst.

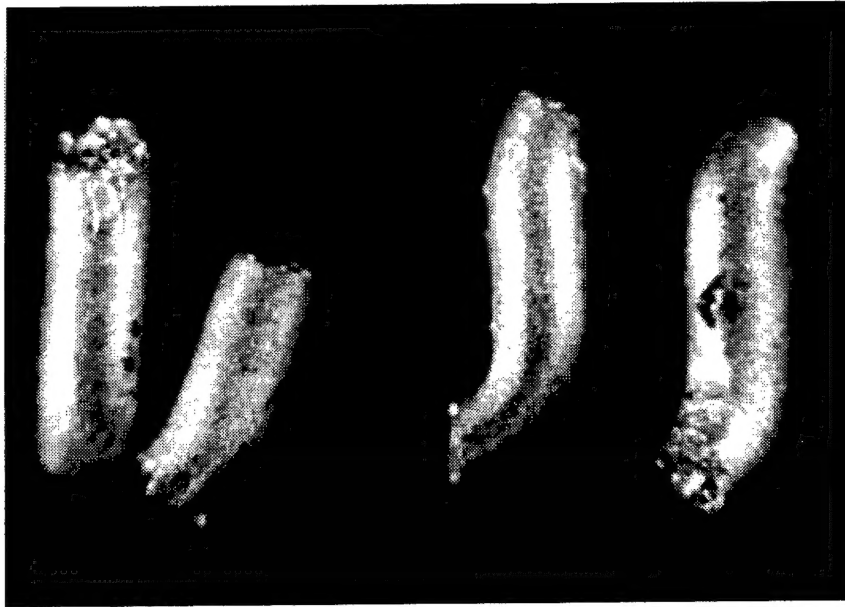
Figure 4. Photograph of four Pt-Ir wire fragments.

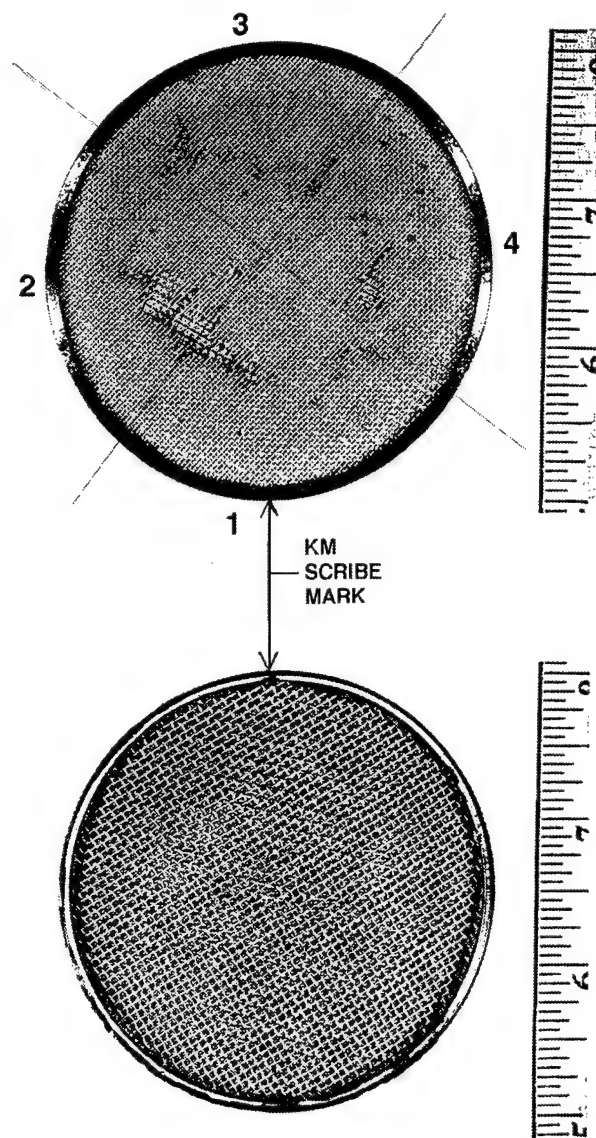
After the motor was disassembled, additional material from the mid-retainer/screen assembly was provided to MMTC for evaluation. Photographs of the front and rear surfaces of the mid-retainer/screen assembly are shown in Figure 5. The top photograph shows a circular pattern of damage to the first 40 x 40 screen due to embrittlement of the 0.010-in.-diam wires. The lower photograph shows that the 18 x 18 mesh of 0.017-in.-diam wires was undamaged. The contractor sectioned the mid-retainer/screen assembly into quadrants by cutting along the lines shown in the upper photograph and sent Quadrant No. 2 to MMTC for evaluation.

Figure 5. Photograph of up stream (top) and down stream (bottom) sides of mid-retainer/screen assembly. Top photograph shows location of cuts for sectioning into quadrants.

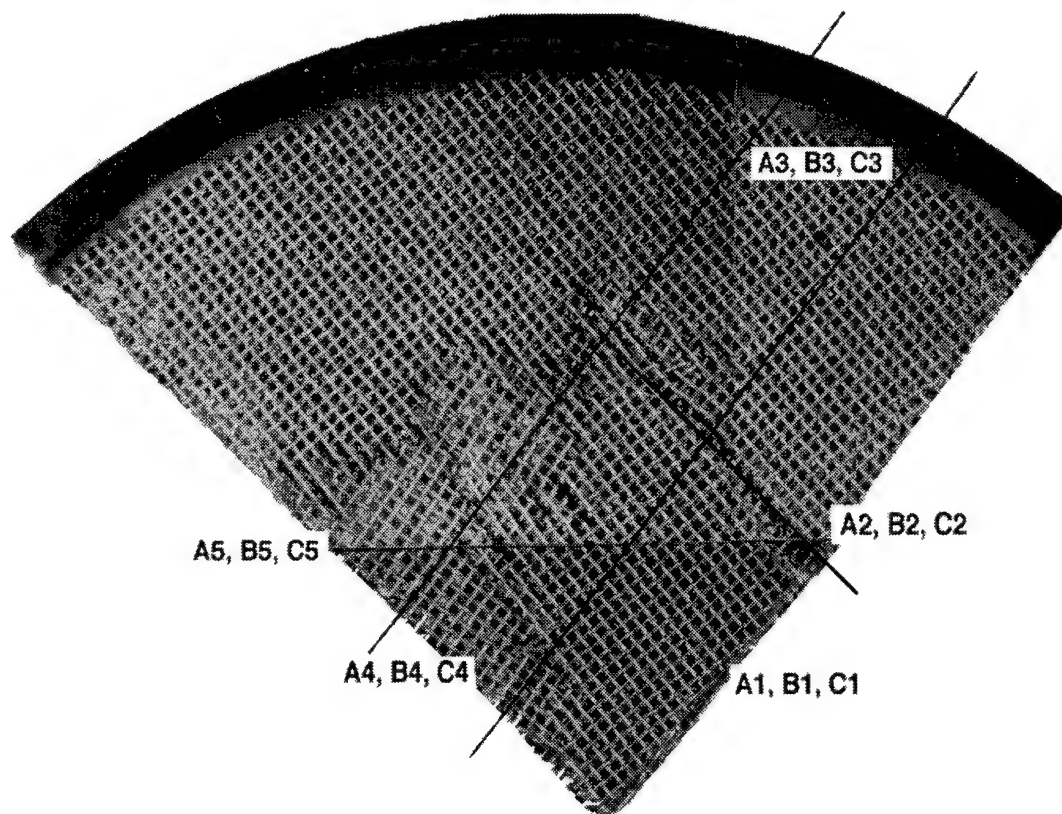
The photograph in Figure 6 shows the damaged areas on Quadrant No. 2 and the cutting pattern for removing smaller samples for various evaluations and experiments. For the purpose of convenient sample identification, the top, brittle screen was identified as Mesh A, the middle screen as Mesh B, and the lower, coarse screen as Mesh C. Initially, the entire quadrant was evaluated using SEM/EDX to document fracture features and conduct preliminary chemical analyses of the wire surfaces and fracture surfaces. The quadrant was then sectioned as shown in Figure 6 using a low-speed diamond saw with deionized water as a lubricant. Samples A1, A2, and B1 were mounted and polished for performing SIMS analyses on wire cross sections. These samples were selected to allow comparisons between areas on Mesh A with and without brittle failures (A1 and A2, respectively) and to compare the damaged Mesh A with the apparently undamaged Mesh B. Samples A3, B3, and C3 were used for SIMS analyses of the wire surfaces. The intent of these analyses was not only to compare the surface chemistry for the three screens, but to also make comparisons between the "high points" (tensile side) of the wires at crossovers in the weave to the "saddle points" (compressive side) where the crossing wires contact one another. The high points can easily be contaminated during handling of the screens, whereas the saddle points are somewhat protected from contamination.

Figure 6. Photograph of Quadrant No. 2 from Mid-Retainer/Screen Assembly. The Screens Were Sectioned into Samples and Identified as Shown. Mesh A = Top, Embrittled Screen, Mesh B = Middle Screen, and Mesh C = Bottom Screen.

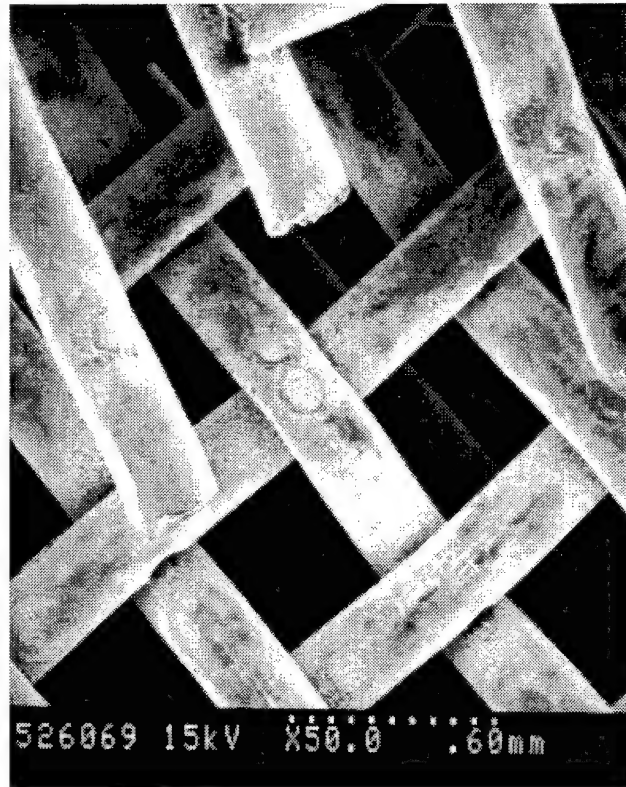
Figure 8. SEM micrograph of damaged area on mid-retainer/screen assembly.

Figure 8 also shows that the wires underwent considerable deformation at the crossover points of the weave. The wire in the upper right corner of the figure appears to be slightly kinked within the saddle point of the crossover. This was a common observation. Figure 10a shows a higher magnification of a kinked saddle point. The saddle points were characterized by a reduced density of catalyst particles and considerable etching of the grain boundaries. Thermal etching of grain boundaries commonly occurs during high-temperature vacuum annealing (brazing operation), but may also occur in high-temperature reducing environments (motor firing). A higher-magnification view in Figure 10b demonstrates that in some areas, grains were completely dislodged. Other saddle points showed complete dissolution of the grain boundaries (Figure 11a), the development of voids at the grain boundaries (Figure 11b), or possible surface melting (Figure 11b). These observations are probably indicative of the embrittlement process and are contributors to the apparent partial fusion between crossing wires.

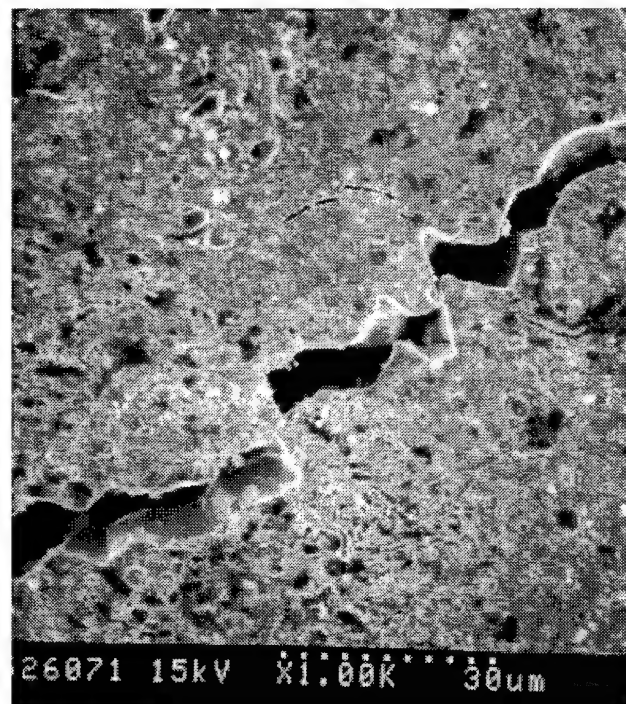
Figure 9. SEM micrograph of cracked Pt-Ir wire on Mesh A.

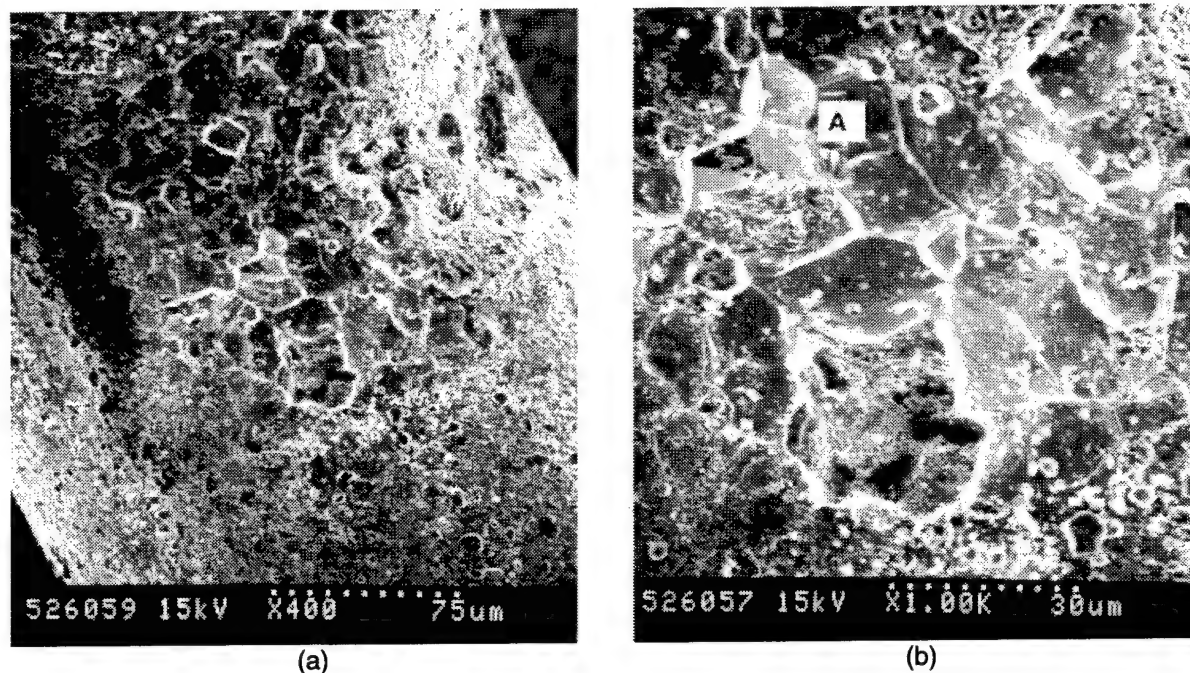
The saddle points shown in Figures 10 and 11 are from areas on Mesh A in which the saddle points were exposed when the crossing wire fractured. In order to view the saddle points on Meshes B and C, it was necessary to extract the crossing wire. Figure 12 shows a saddle point on Mesh C, which has the appearance of a ductile fracture surface. This fracture surface is direct evidence that the crossing wires were fused together. Figure 12 is typical of all saddle points (4 or 5) examined in the SEM for Mesh C. A larger number of saddle points was examined on Mesh B. Most of the Mesh B saddle points had the ductile fracture surface characteristic of the separation of fused wires over part of the crossover area and the "free surface" features shown in Figures 10 and 11 over the remainder of the area.

Figure 10. SEM micrographs of a saddle point of a crossover point on Mesh A. The higher-magnification micrograph (b) shows dislodged grains at point A.

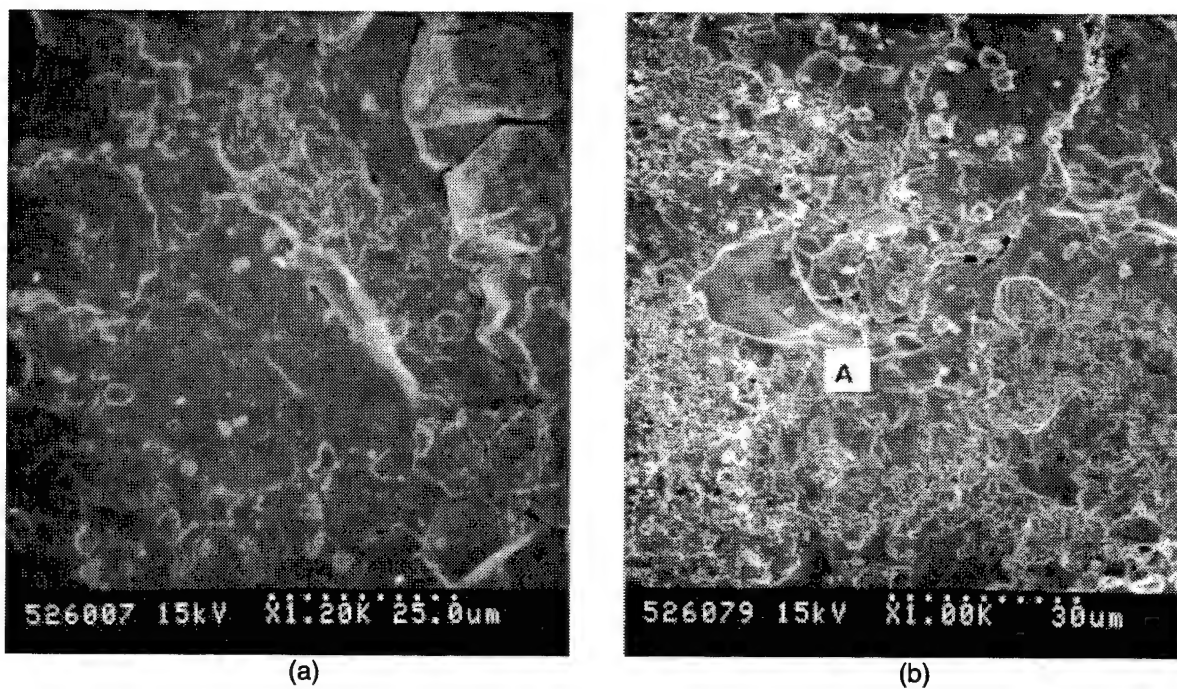
Figure 11. SEM micrographs of two saddle points at crossover points on Mesh A. Extensive grain boundary dissolution is shown in (a). Grain boundary voids along with possible melting at location A are shown in (b).

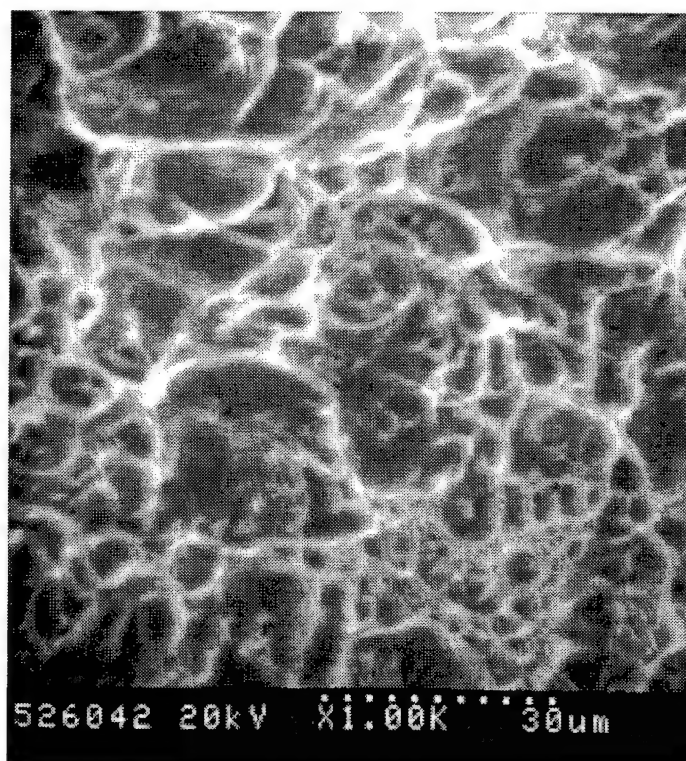
Figure 12. SEM micrograph of a saddle point of a crossover point on Mesh C.

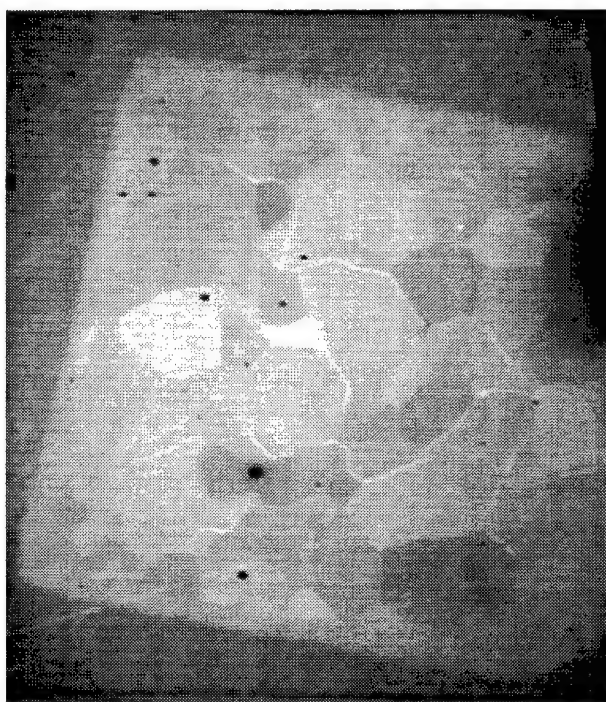
Initially, there was some concern that the Si- and Ca-rich particles might be contamination from the SiC abrasive paper used in the sample grinding operation. However, additional mapping indicated that there was no carbon associated with the particles. Furthermore, it was discovered that during depth profiling, some of the particles were sputtered away while new particles appeared at different points. Thus, it was concluded that the particles were present within the bulk of the samples and were not a sample preparation artifact. The relative spatial positioning of the particles, as demonstrated by the Ca map in Figure 14, suggested that the particles could be located at the grain boundaries. Unfortunately, the magnification (70x) of the optical microscope on the microprobe was not adequate to sufficiently resolve the grain structure to make any correlation between the relative locations of the grain boundaries and the Ca-Si particles. However, the ion beam does etch the sample over the 100- μ m analysis area. Therefore, the analysis area could subsequently be identified with the SEM and is shown in Figure 15. EDX analyses indicated that most of the dark spots in Figure 15 are composed of Ca, Si, and O. The other dark spots appear to be voids left behind by dislodged particles. These particles are assumed to be the same as shown in Figure 14, and some correlation in the location of the particles can be seen when comparing the two figures. The most significant observation from Figure 15 is that most of the Ca-Si-O particles are located within the grains rather than at the grain boundaries. For this reason, it was concluded that these particles probably did not cause the embrittlement of Mesh A. This conclusion was further supported by the fact that the particles were not only observed by SIMS mapping on all Mesh A samples, but were also present on Mesh B (Sample B2), which showed no evidence of embrittlement.

Figure 15. SEM Micrograph of Area B on Sample No. A2 following SIMS analysis. EDX analysis indicated that dark spots are Ca-Si-O particles.

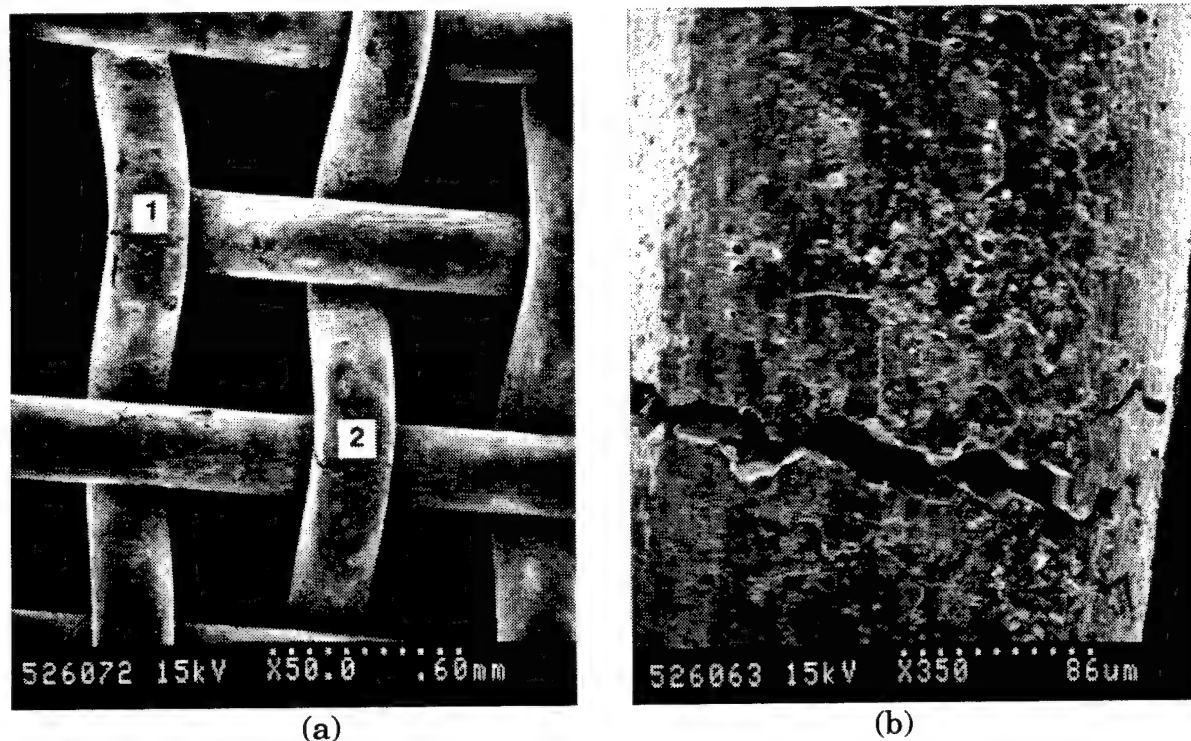
Sample Nos. A3, B3, and C3 were examined in the SEM following the SIMS analyses. Figure 18a shows Areas 1 and 2 from the SIMS analyses on Sample No. A3, and Figure 18b shows a higher-magnification view of Area 2. A comparison of Figure 18b with Figure 9 shows that the 90-min ion sputtering during the SIMS analysis cleaned a significant fraction of the catalyst particles from the wire surface and also etched the grain boundaries. Extensive EDX over the etched area did not reveal any elements other than Pt, Ir, Al, and O. Thus, although the Mn/Pt and Ga/Pt secondary-ion count ratios after sputtering were very high on Area 2 (Figure 16), the actual concentrations of Ga and Mn were too low to be detected by EDX.

Figure 18. SEM micrographs of Sample No. A3 following SIMS analysis. Micrograph (a) shows Areas 1 & 2 adjacent to cracks. Micrograph (b) is higher-magnification view of Area 2.

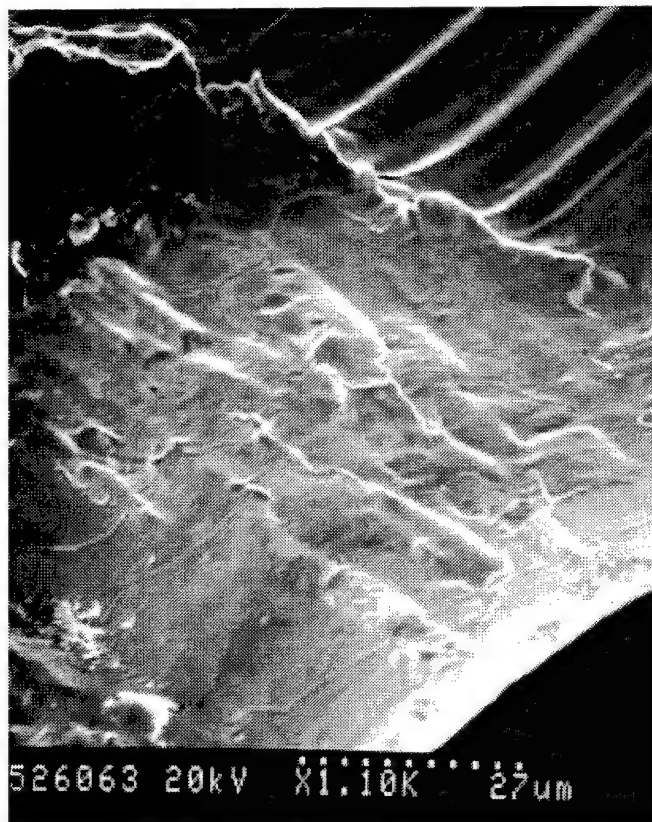
The Kaiser Marquardt Pt-Ir screens designated Lot Nos. 1 and 2 that were subjected to the braze simulation heat treatment were submitted to MMTC for evaluation. The primary goal was to determine whether these screens exhibited the partial fusion at weave crossover points that were observed for the screens from REM S/N KM004. Lot No. 1 was heat treated at 1150°C (2100°F) for 2 h to simulate the braze operation. Lot No. 2 was subjected to this heat treatment twice. Wires were extracted from both screens under a stereo microscope at a magnification of 20x. For both heat-treated lots, the wires were very easily extracted with no indications of fusion between wires. Figure 19 shows that the wires were subjected to substantial deformation at the crossover points, not unlike the deformation experienced by the wires in the S/N KM004 screens. However, the wires in the Lot No. 1 and 2 screens showed no evidence of the dislodged grains, dissolution of grain boundaries, voids at the grain boundaries, or fusion between wires seen on the embrittled wires.

Figure 19. SEM micrograph of a saddle point of a crossover point on Kaiser Marquardt Lot No. 2 screen following heat treatment simulating brazing.
